**Springshed:** Identifying Recharge  
Areas of Drying Springs and Lakes  
with  
Water Quality in Southwestern Bhutan

Volume I

**Tarayana Foundation  
Thimphu, Bhutan  
2022**

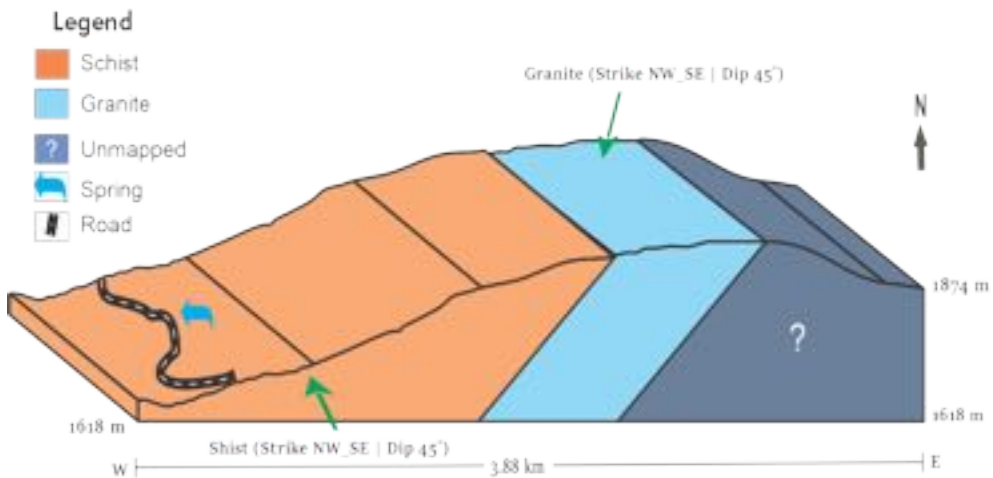
Hydrogeological Layout of the Zookpolung Spring

Figure 2: Hydrogeological Layout the of the Zookpolung spring

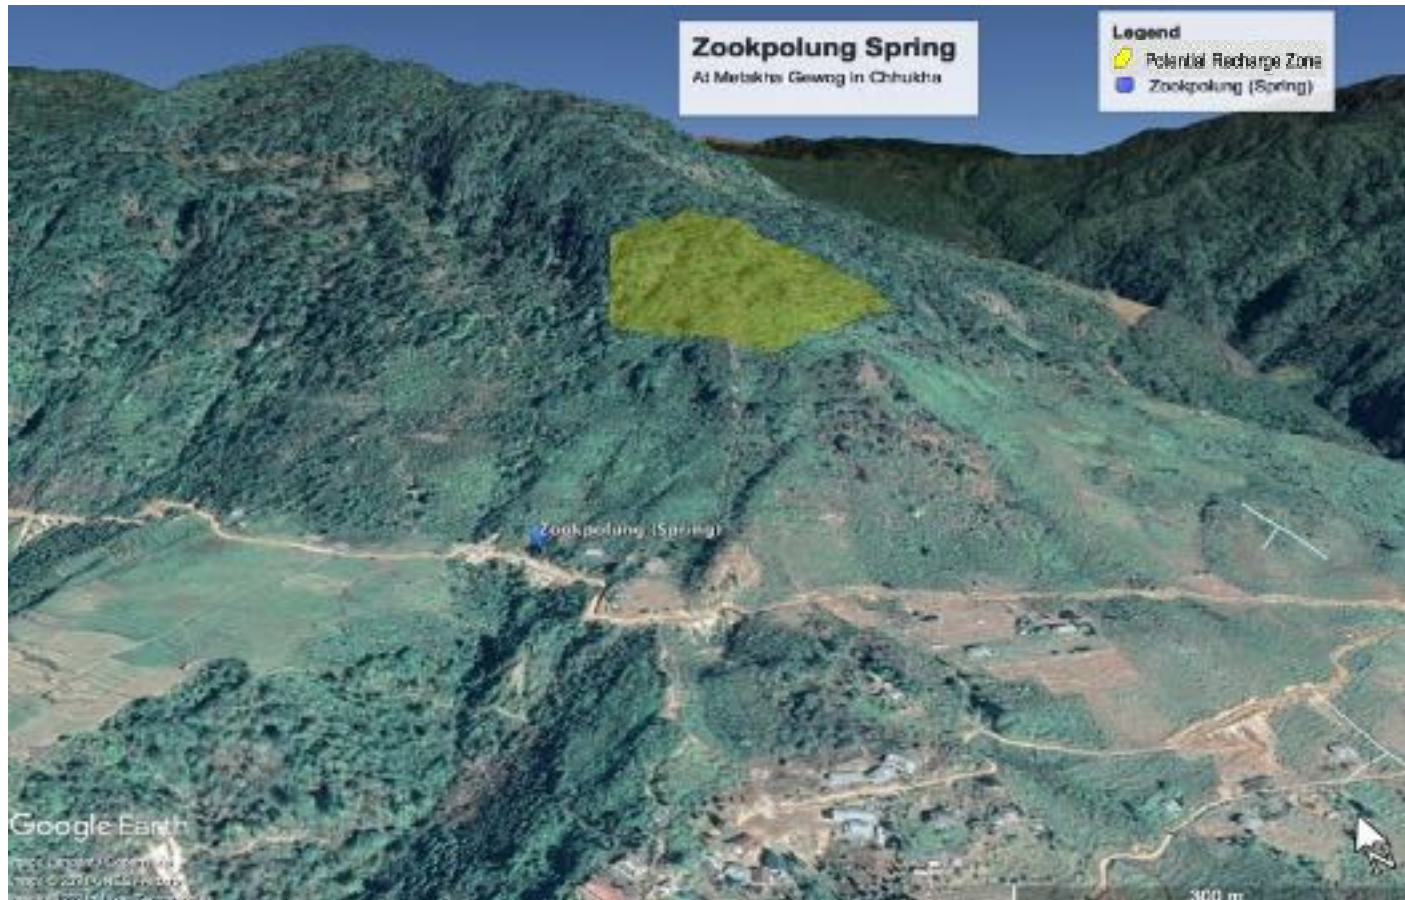
**Figure 6:** Location of the recharge area and Zookpolung spring on the Google Earth image.

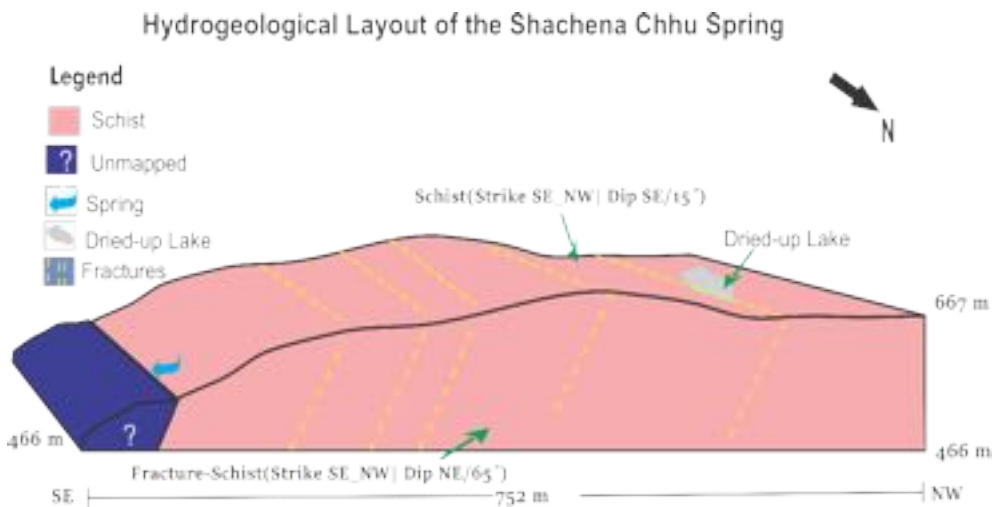
Shachena Chhu spring emerges on the southeast slope of the mountain ridge. The entire ridge is comprised of schist. The multiple fractures in the schist dip  $15^\circ$  towards the southeast and are highly weathered in places. The multi-structural geological formations are observed just above the dying spring. At the same elevation there is another spring for animal drinking that is aligned with a fracture set (dip  $65^\circ$  towards the northeast). Therefore, these springs are classified as fracture springs. There is thick debris along the fracture plane that conveys the water to the spring. This also indicates that the spring is a combination of depression and contact type. The recharge areas for this spring follow the orientation of the fracture sets towards the dried-up Thasa lake on top of the ridge toward the southwest.

**Figure 2:** Hydrogeological Layout the of the Shachena Chhu spring

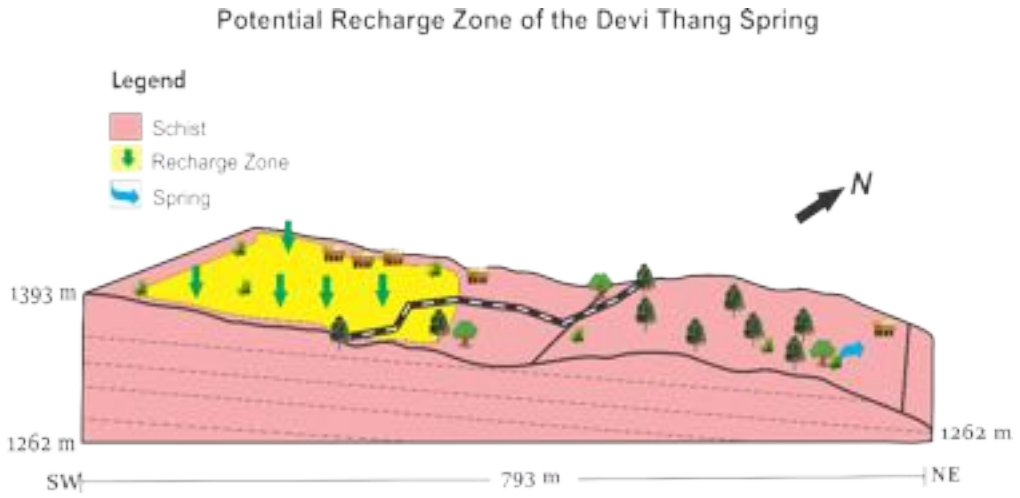
**Figure 3:** Potential Recharge Zone of the Devi Thang spring

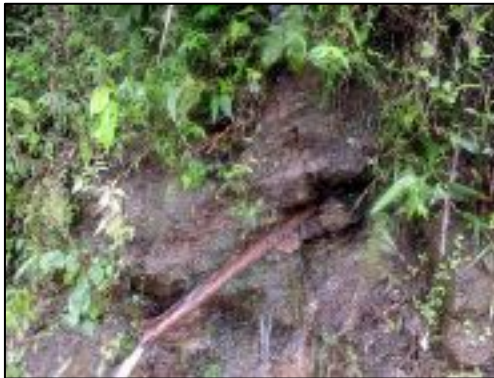
**Figure 4:** Fracture spring source in nearby aquifer

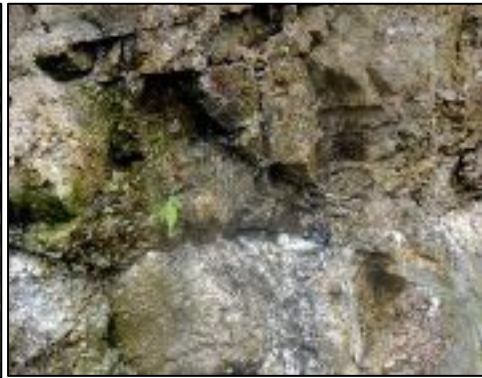
**Figure 5:** Lithology of Nimtola

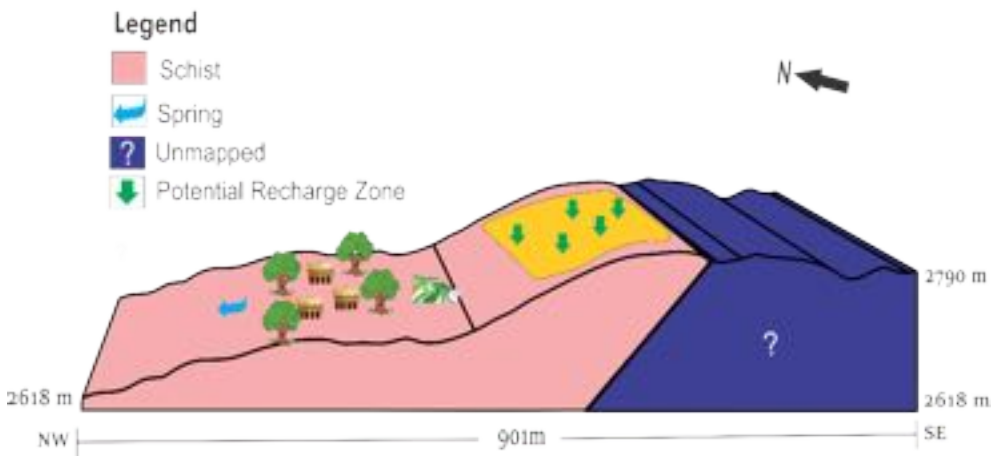
Potential Recharge Zone of the Chetoe Goempa Spring

**Figure 3:** Potential Recharge Zone of the Chetoe Goempa spring

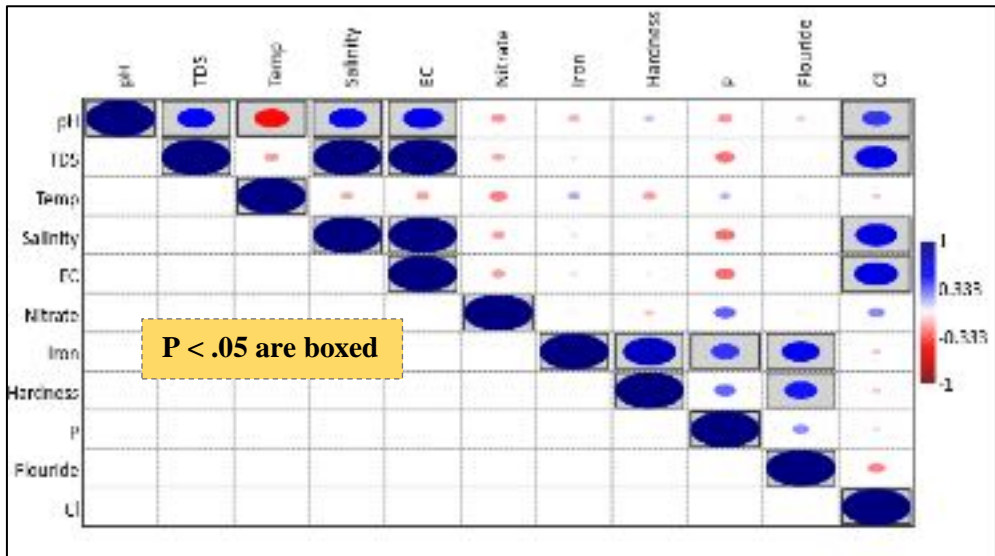
**Figure 8.3.** Correlation matrix of water quality variables ( $n = 29$ )
